WaterWorld®

District Puts Plastic Pipe to the Test

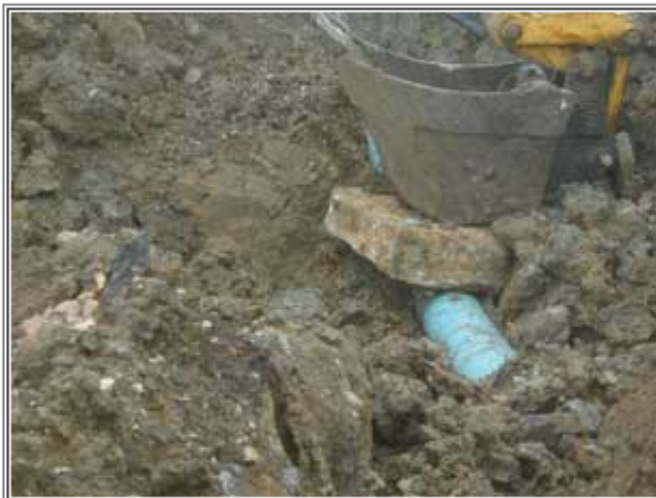
Hot soil in the Water One district calls for a pipe that won't corrode.

Water District #1 made the switch to plastic pipe to combat corrosion problems. Soil in the area is generally considered "hot," Schade said.

"We needed to pick a product that doesn't corrode and will provide a long-lasting infrastructure," he said.

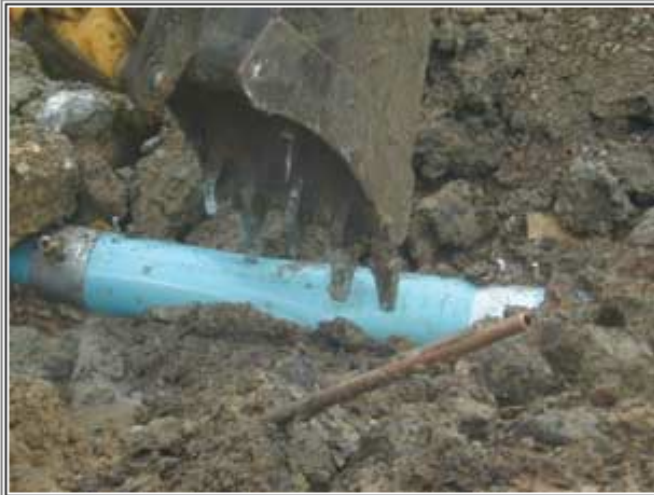
Water One put C909 plastic pipe to the test with a backhoe before putting it into use.

"We filled it to 300 psi and had it lying on the ground and took a back hoe to it," Hamilton said. "We had to hit with the tooth on the bucket to break it—not just push down, but hit it. It was pretty amazing. I was impressed with its strength, and particularly impressed with how it doesn't split out when outside forces damage it."
